SPANS

The Quarterly Newsletter of Inspired Bridge Technologies

April 2008, Volume 6

CONCRETE REPLACES STEEL SUPERSTRUCTURE (on Existing Foundation)

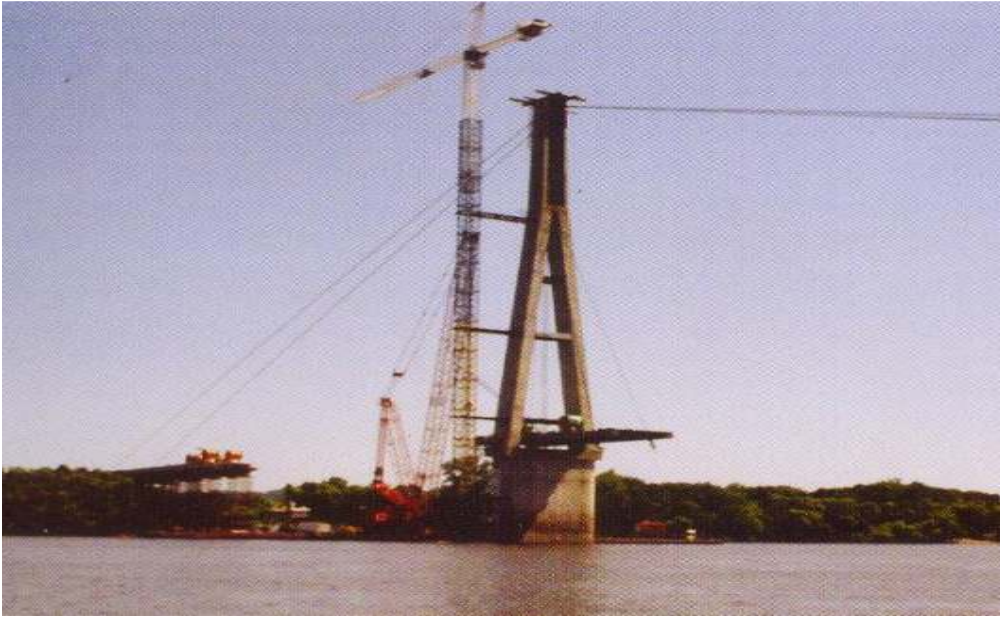
FIGURE 2: Ohio shoreline view of the guyed, 278.83' tall concrete pylon atop the 87' high, existing, main river pier.

sequence included the addition of the 278.83' pylon to the existing 87 foot tall main river pier. The 275 ton, cable-stayed, pre-cast, deck girder segments were erected alternatively about the main pylon, one side at a time (Figure 4). The unbalanced bending loads that would have been introduced into the main pier foundation by the back and forth deflections of the pylon were greater than for the steel alternate and to mitigate this tendency a temporary forestay and backstay were attached to the pylon-head to reduce this tendency (Figure 2).

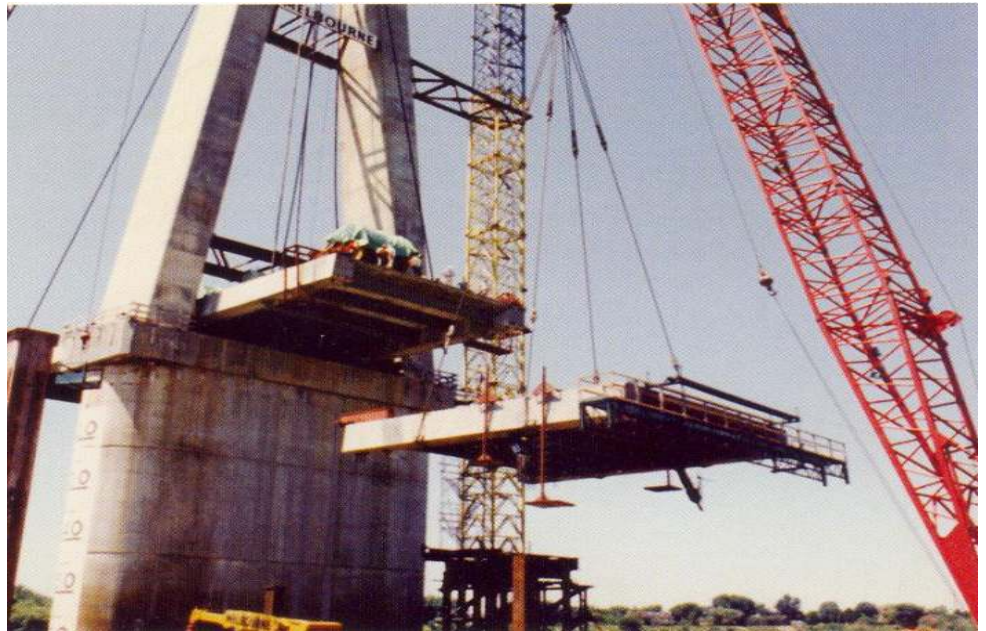
FIGURE 4: Barge mounted crane hoists 275 ton, pre-cast concrete, deck segment with alignment tongue in view

A Construction Cycle consists of the advancement of the form traveler to the leading edge of the cable-stay supported segment. The so called form traveler is a two part, structural steel, clamping devise positioned on top of each edge girder that guides, aligns, and then temporarily holds the new segment 12" off the installed segment in order to allow epoxy application to the two interfacing surfaces before they are drawn together and connected by post tensioning bars. This tongue and groove mechanism has the groove firmly bolted to the fixed element and the tongue is likewise attached to the top of the new, crane supported segment.

This procedure was necessitated because the new segment was installed from a barge mounted crane, floating on a heavily traveled river, which held the new segment against the form traveler until the two stays are attached and stressed to support the front end of the segment. The form traveler supports the back end of the segment through the stay adjustment period and is removed after the segment is firmly post-tensioned to the preceding element.

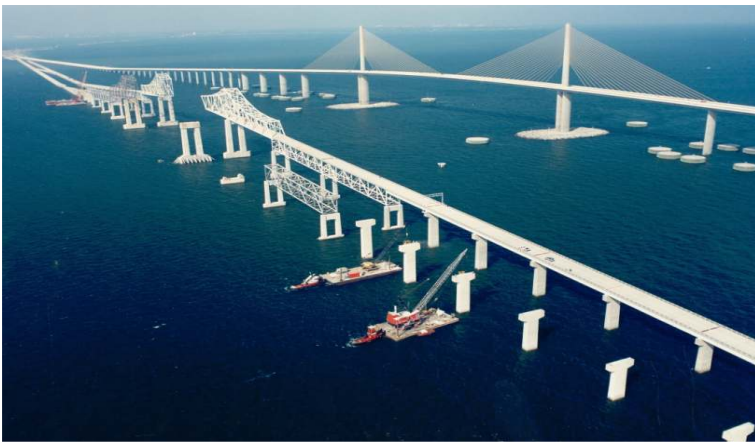
Disassembly and demolition began and with it came several difficult engineering challenges that had to be resolved: the order of disassembly, a safe method for detonating charges, and the safe removal of the remaining bridge's main span. A system was developed by the engineering team for a 4 x 1:16 ratio pulley system at all four corners of the main span and it was connected to 4 different 25-ton winches which lowered the steel span down to a waiting barge at a decent rate of up to 30 feet per minute. The whole process took 2 1/2 hours to lower the 608 ton segment to the deck of the barge.
